RE: Pregnant Pond Liner Repair and Test Certification - North Lily Mining Company, Silver Peak Facility

Air Pressure Test Certification

Project: North Lily Mine

Basin/s: Pregnant Solution Pond

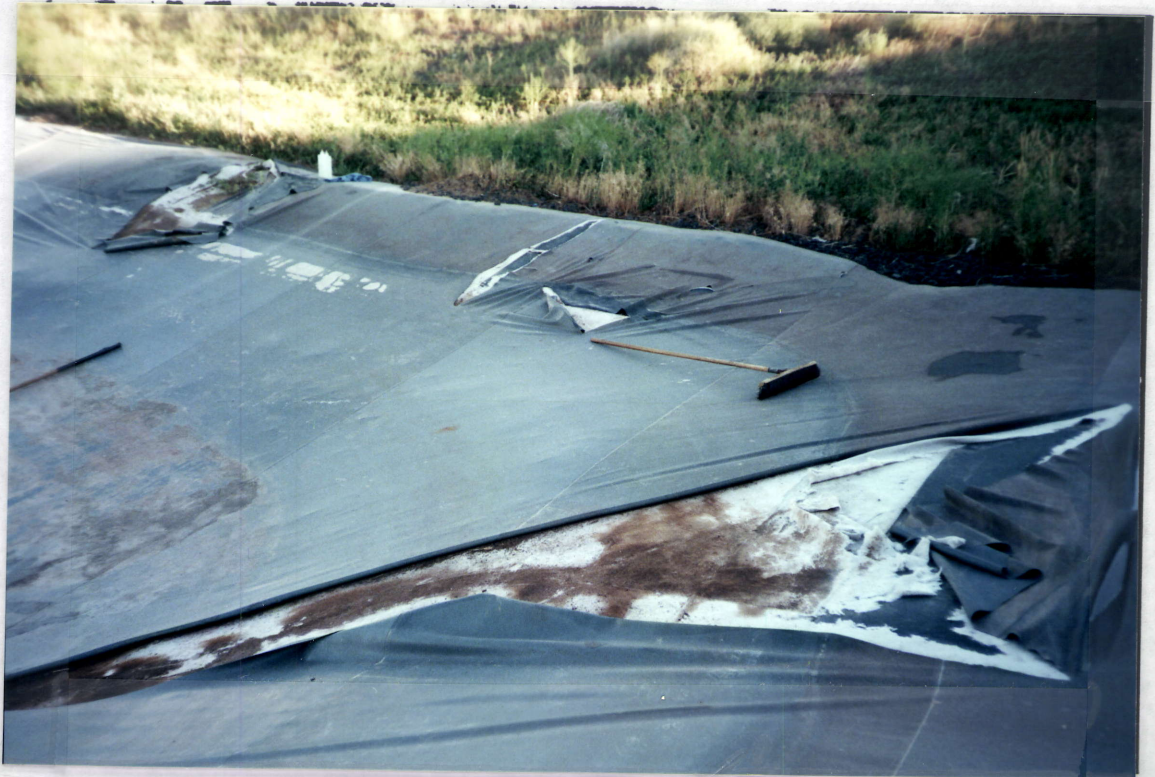
Four Major Repairs

#1 30' From N.E. Corner #2 18' From N.E. Corner #3 In N.E. Corner

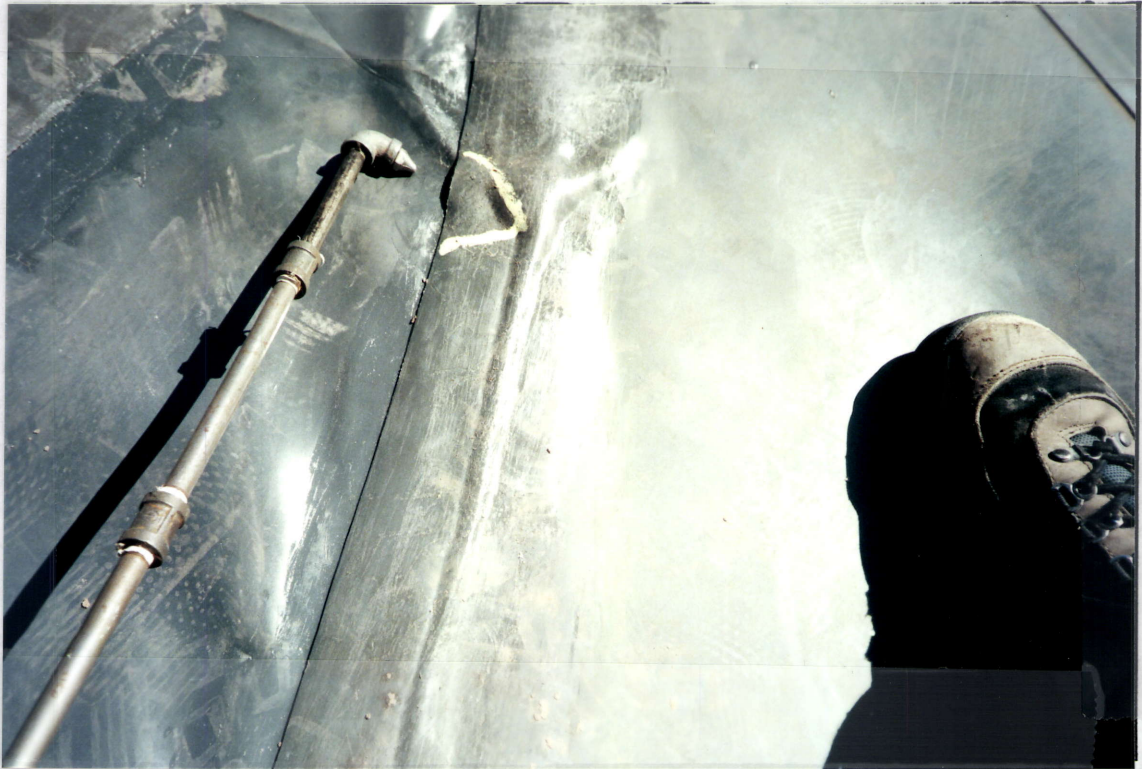
Air Lance Test 60 PSI through 1/8" Orifice
Note Air Lance shows leak path and all nonbonded areas
